Upper Paradise Creek Sub-Watershed Potential Restoration Sites

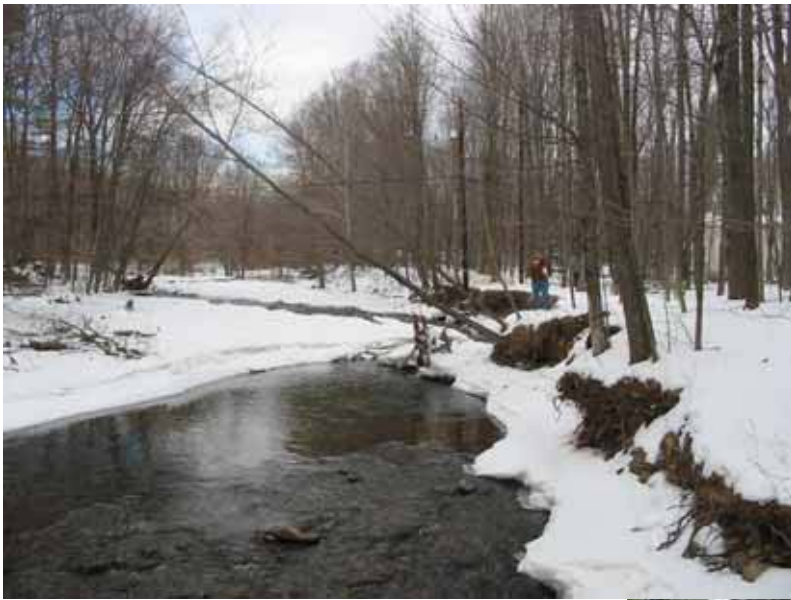
1. Paradise Creek upstream to downstream of Red Rock Rd crossing – channel migration, incision, widening.
2. Paradise Creek in vicinity of abandoned Pocono Gardens Resort – runoff, channelized, breached dam, road crossings.

Figure 19 – Upper Paradise Project 1: Paradise Creek from the vicinity of Red Rock Road to Lake Crawford. Previously channelized, this reach is now widening, forming meanders, and threatening private property. Note the telephone pole in background, once about 15 feet from the stream, is now about to be undermined. A more detailed assessment and restoration is recommended from Red Rock Road to Lake Crawford.

Large project - protect private property and stabilize up to 1 mile of stream.

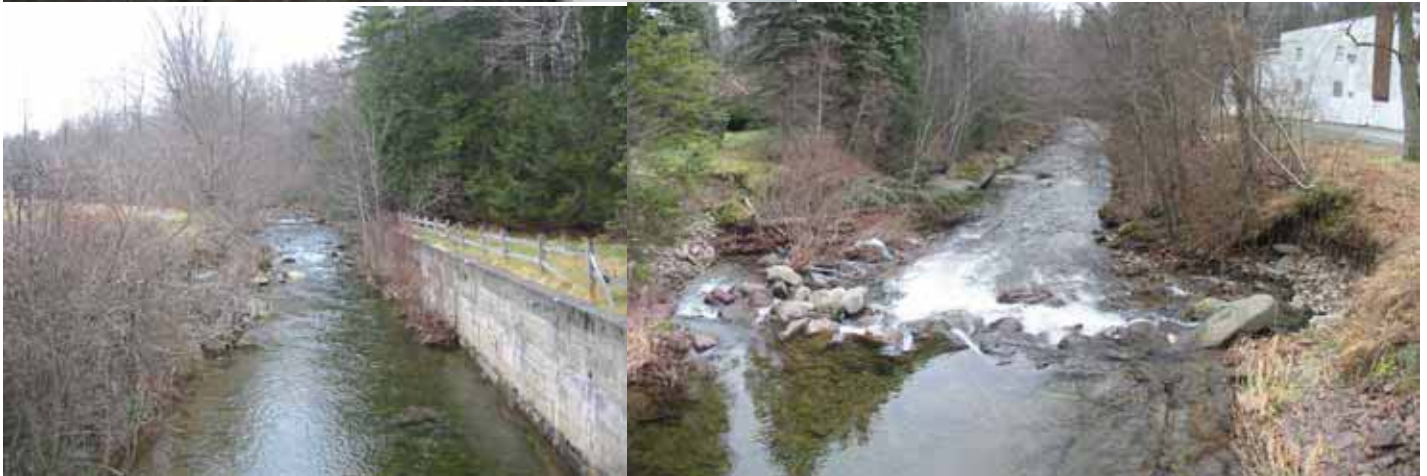
Figure 20 – Upper Paradise Project 2: Pocono Gardens Resort Site – upstream view of channelized section (above) and downstream view past breached dam (right).

Long channelized reach produces high energy downstream. Improve habitat, reduce energy, restore channel upstream of breached dam, create stormwater management plan, install BMPs. Address road runoff and runoff effects of stable.

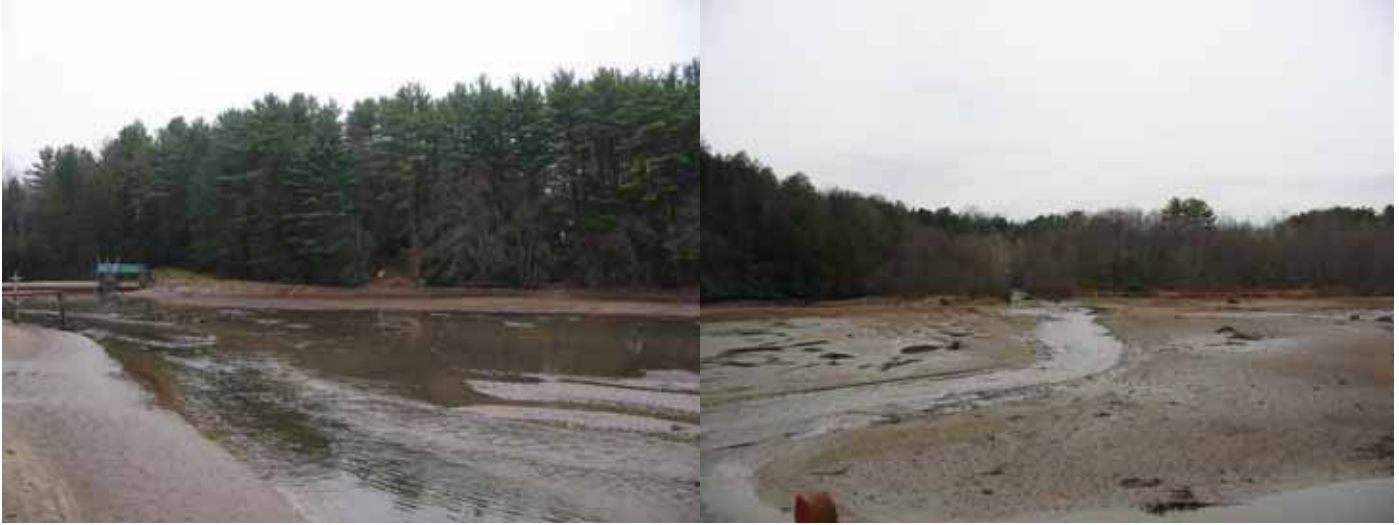
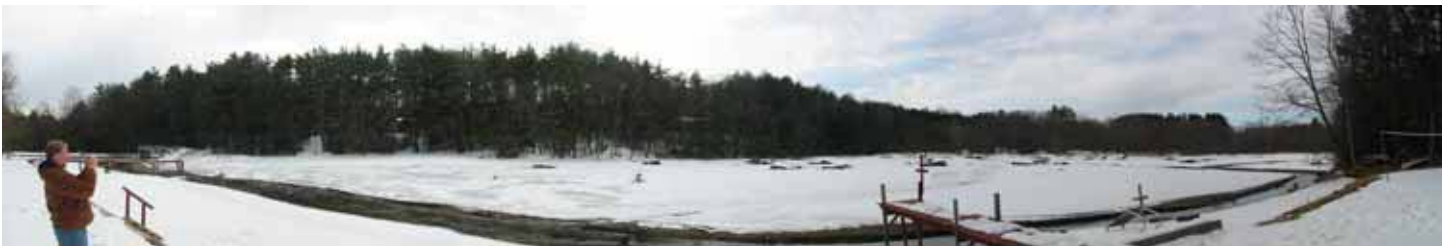
4. Paradise Creek at Crawford Lake dam – dam effects.
5. Paradise Creek upstream of and entering Lake Crawford – channelization, sediment bar, wandering channel into lake.

Figure 21 - Crawford Lake dredging, December 2004: Once the lake is dredged, a sediment forebay could be created for future sediment capture and maintenance, and approximately ½ mile of upstream stabilization of Paradise Creek. Installation of a fish passage structure and additional habitat improvements are recommended. Left – Downstream view toward dam. Right – Upstream view of Paradise Creek entering Lake Crawford. Below – panoramic view of dredging project taken February 2005.

Install fish passage structure. Implement lake management recommendations.

Install sediment capture forebay, maintain regularly. Possible large restoration project to ½ mile upstream of lake.
